Expanded Site Inspection
Final Report

Bill's Excavating
Lockport, Illinois
ILD 980 704 845

February 1997

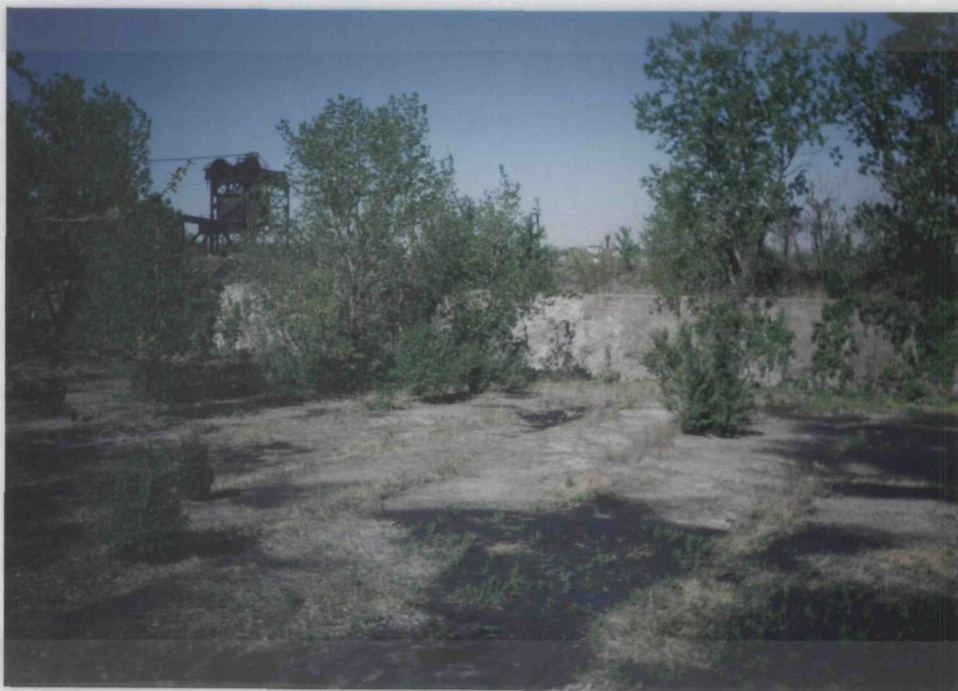
Site: Bill's Excavating Site
Proj. #: 71280.121
Roll: 1 Photo #: 1R
Date: 5-12-94 Time: 0945
Description: Reconnaissance photo, taken
facing southwest showing an
old coal storage area.

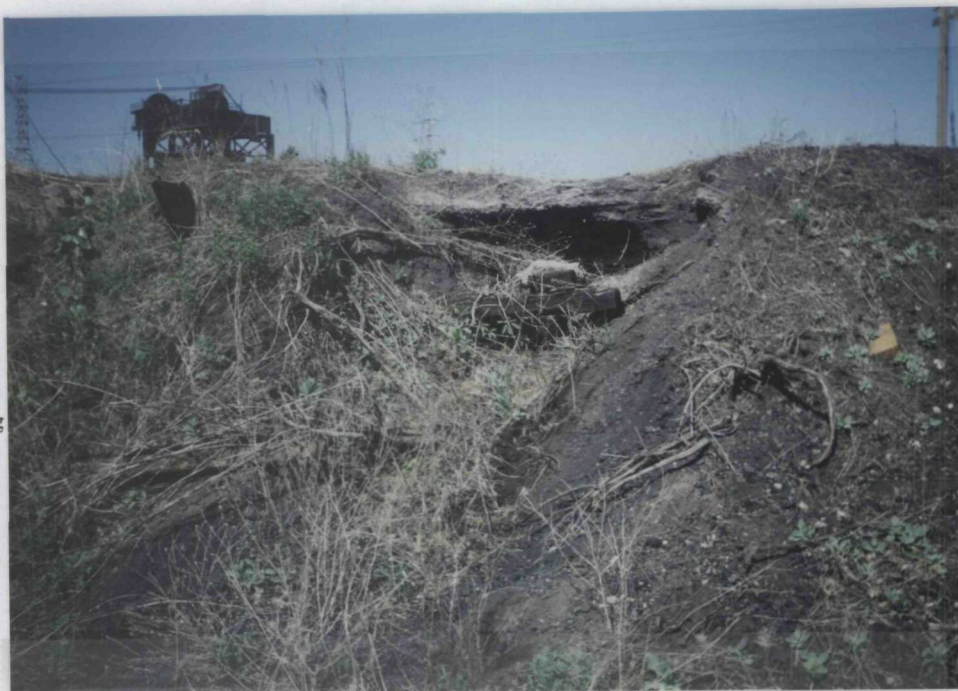
Site: Bill's Excavating Site
Proj. #: 71280.121
Roll: 1 Photo #: 2R
Date: 5-12-94 Time: 1000
Description: Reconnaissance photo taken
facing west; shows an area
where fill was eroded, making
it possible to view buried ties
and coal/coal ash.

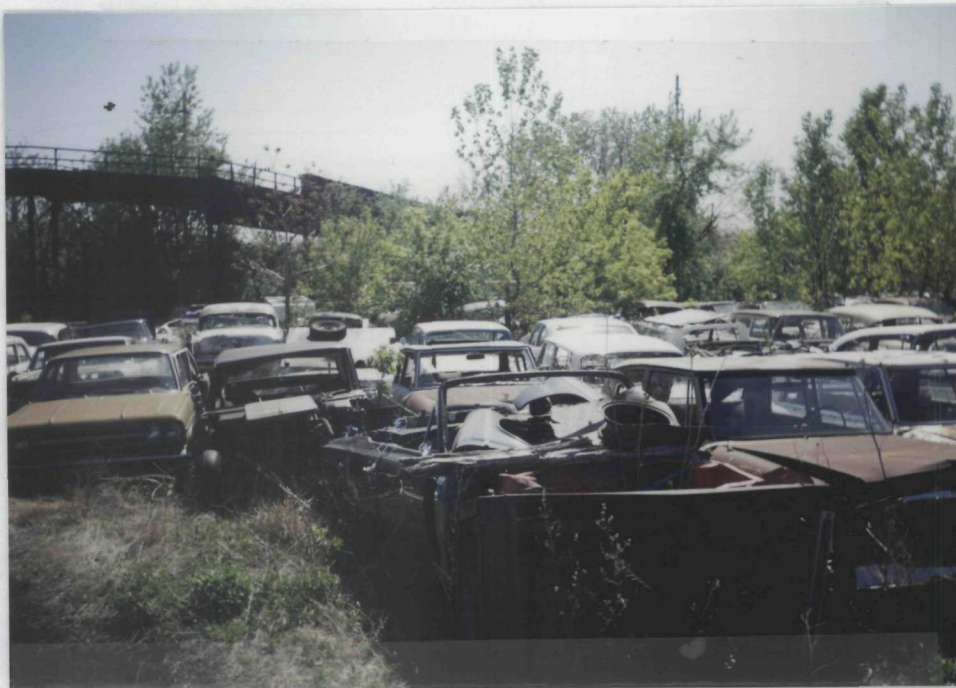
Site: Bill's Excavating Site
Proj. #: 71280
Roll: 1 Photo #: 3R
Date: 5-12-94 Time: 1015
Description: Reconnaissance photo taken facing east, while standing along a path through junk yard, shows junked vehicles with the site's elevated main entrance road in background.

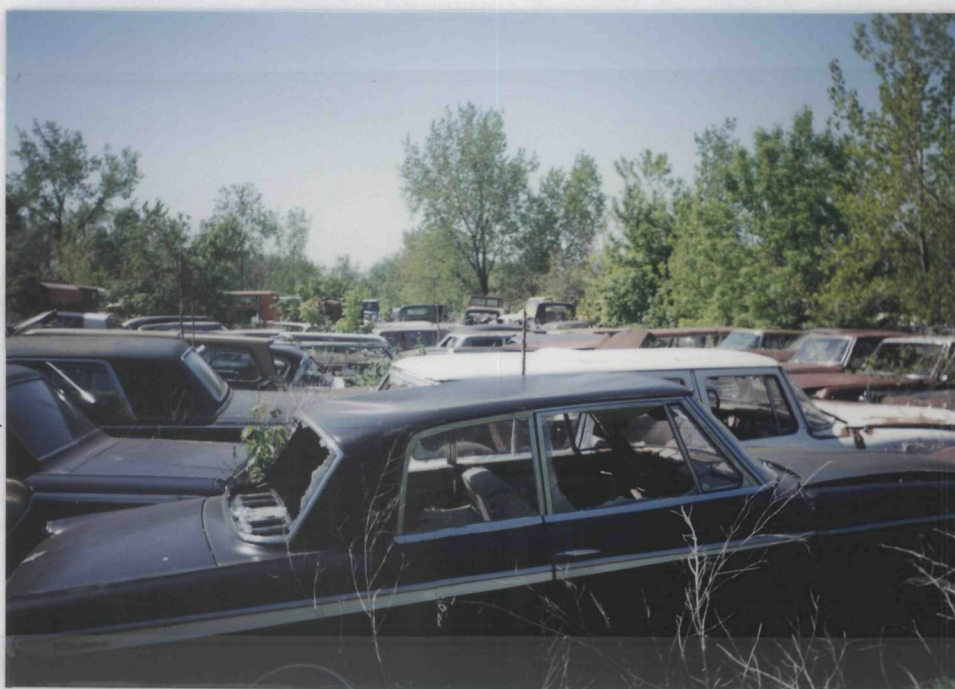
Site: Bill's Excavating Site
Proj. #: 71280
Roll: 1 Photo #: 4R
Date: 5-12-94 Time: 1016
Description: Reconnaissance photo taken facing south, showing junked vehicles in the junk yard area.

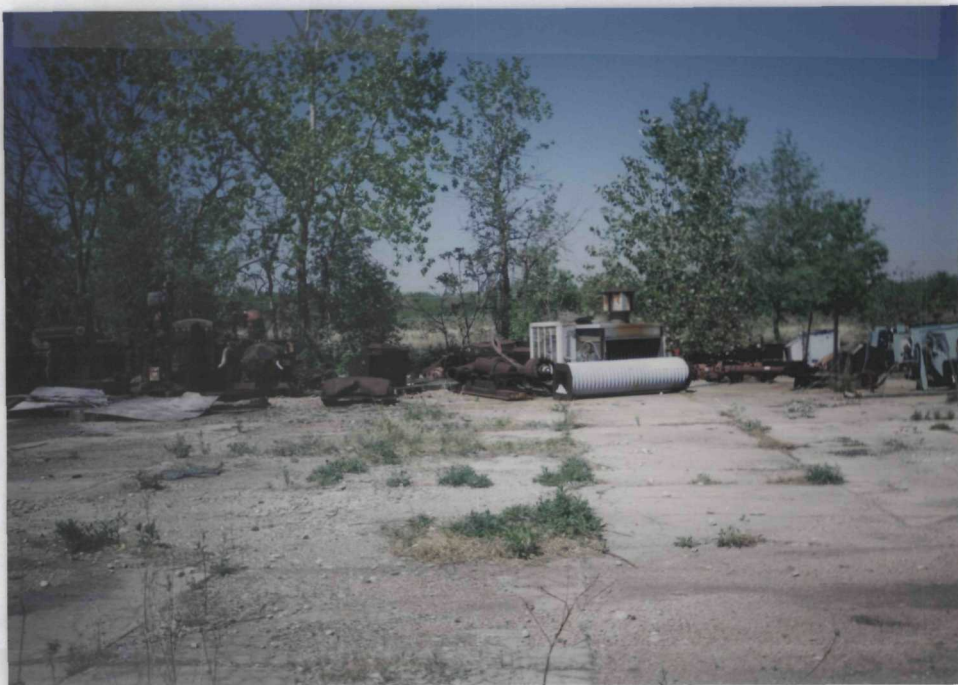
Description: Reconnaissance photo taken facing west, showing a concrete foundation with old rusty farm equipment.

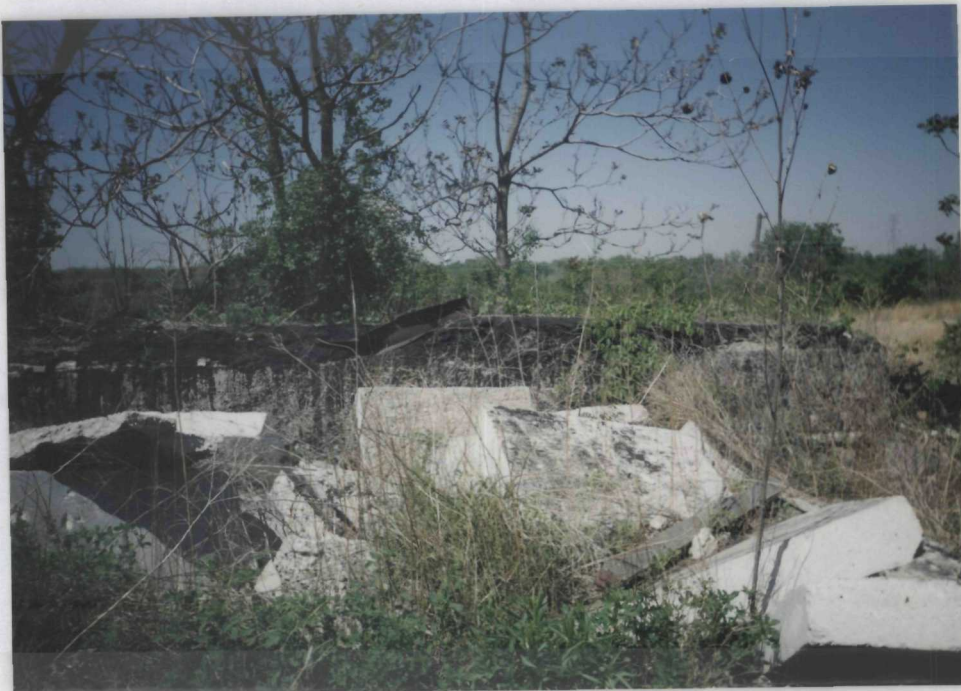
A concrete foundation, approximately 50 feet by 15 feet, in the northwest section of the site is covered with about 9 inches of coal tar. Drip stains from the coal tar waste were observed along the sides of the foundation which is about 3-feet high. North of the tar-laden foundation, tar globs were observed in debris of recently leveled buildings. The tar appeared to be soft as a result of heating from direct sunlight and generated a strong odor. The exposed coal tar waste is uncontained and constitutes an observed release to the soil exposure pathway. The exact amount of coal tar waste and associated contaminated debris and soil at the Bill's Excavating site is unknown; however, ESI personnel estimate 662.5 cubic feet (24.5 cubic yards) of the hazardous substance were observed.

Description: Reconnaissance photo taken facing west, showing coal tar-like material layered over a concrete riser/foundation and concrete slabs/debris.

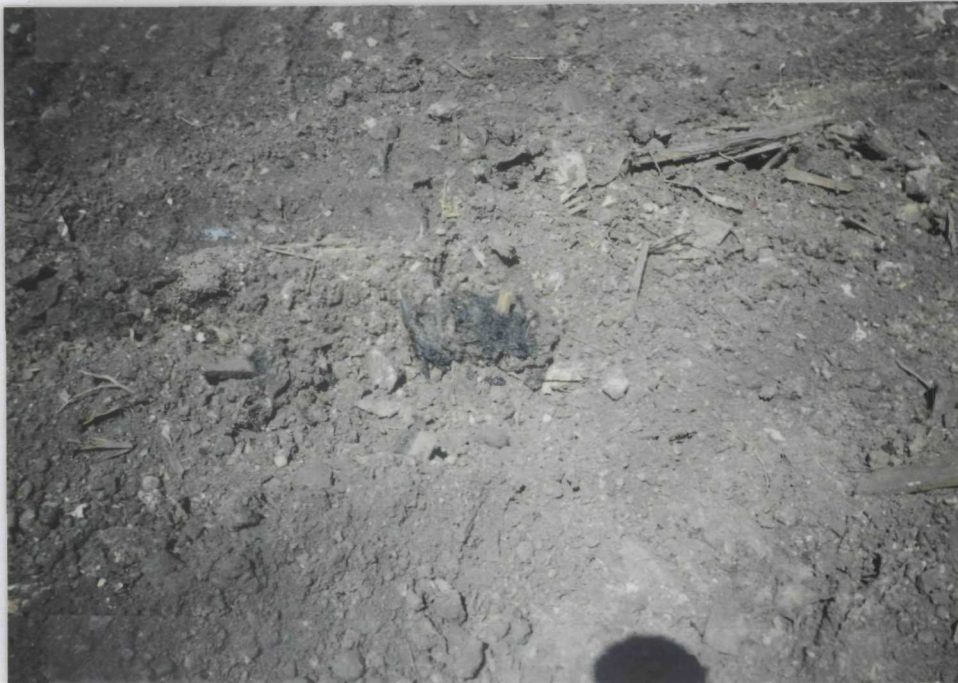
Site: Bill's Excavating Site
Proj. #: 71280.121
Roll: 1 Photo #: 7R
Date: 5-12-94 Time: 1055
Description: Reconnaissance photo taken facing west, showing exposed coal tar and other debris in a graded (leveled) area.

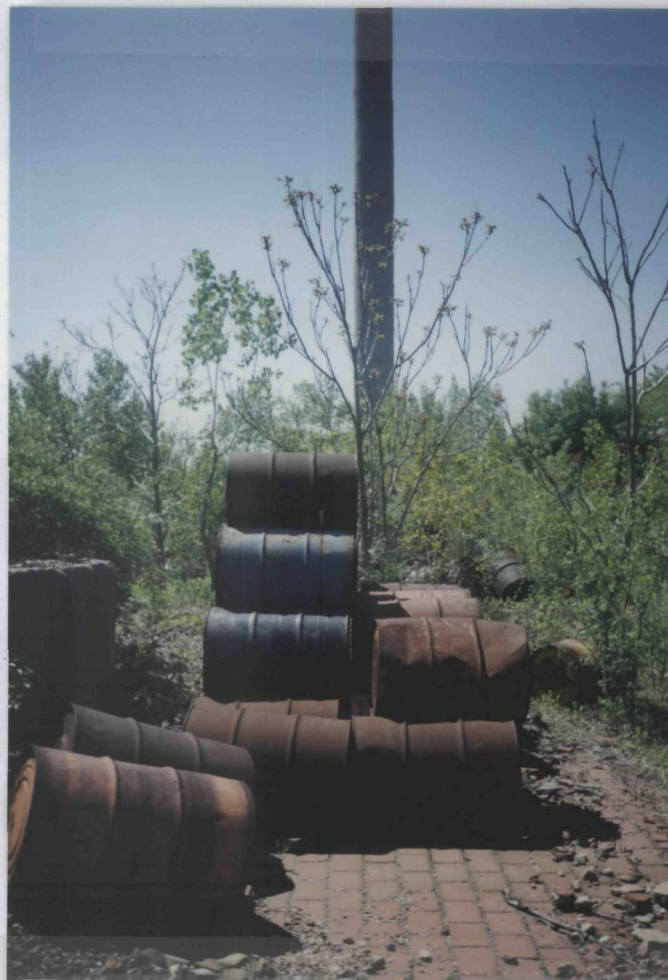
Site: Bill's Excavating Site
Proj. #: 71280.121
Roll: 1 Photo #: 8R
Date: 5-12-94 Time: 1115
Description: Reconnaissance photo taken facing south, showing rusty drums piled up on a ceramic tile pad, north of the onsite smokestack.

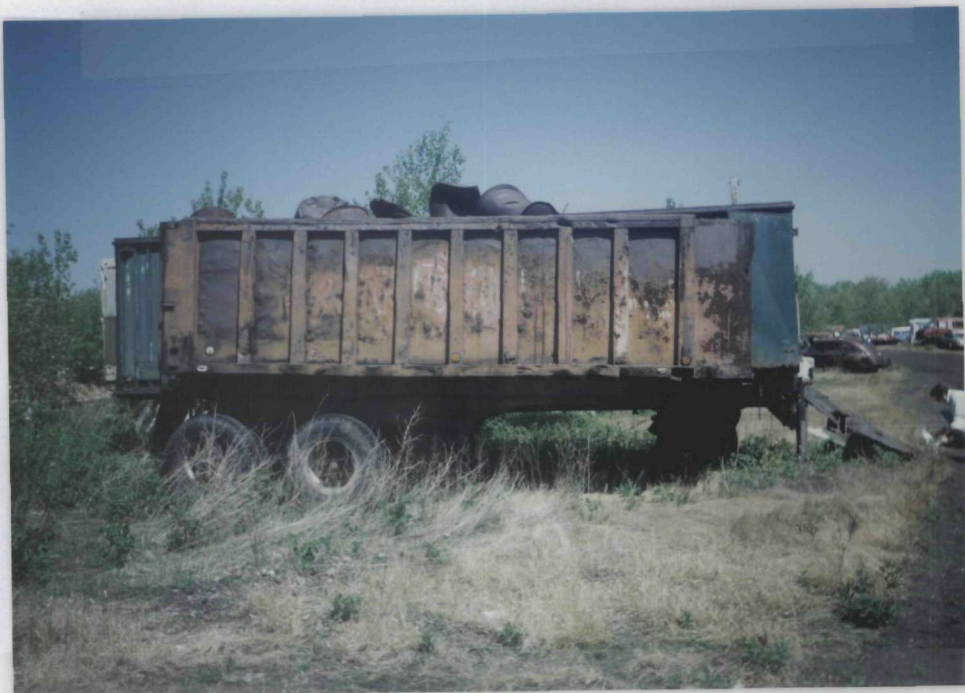
An open trailer filled with drums leaking a resinous material is located in the northeastern section of the Bill's Excavating site. This exposed waste establishes an observed release to the soil exposure pathway. Resinous waste was observed on the ground outside the trailer and crusted to the back end of the trailer, below the trailer bed. Fresh resinous waste was also seen oozing out of at least one drum in the

Site: Bill's Excavating Site
Proj. #: 71280.121
Roll: 1 Photo #: 9R
Date: 5-12-94 Time: 1120
Description: Reconnaissance photo, taken facing north, showing an open trailer filled with numerous rusty drums.

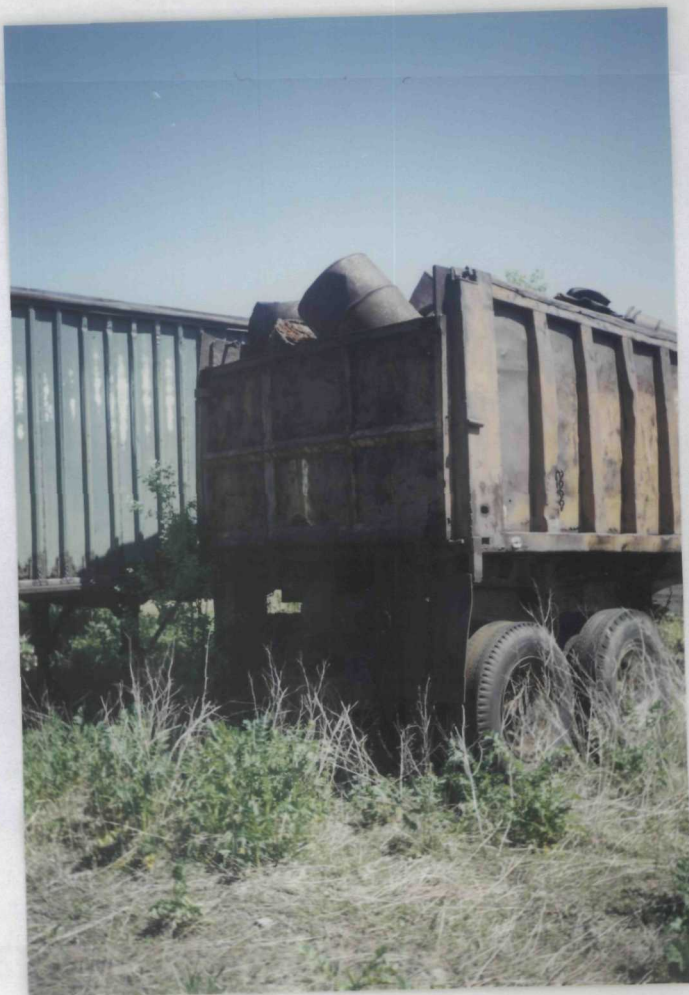
Site: Bill's Excavating Site
Proj. #: 71280.121
Roll: 1 Photo #: 10R
Date: 5-12-94 Time: 1125
Description: Reconnaissance photo, taken facing north, showing crusted resinous material on the top of a drum in the trailer.

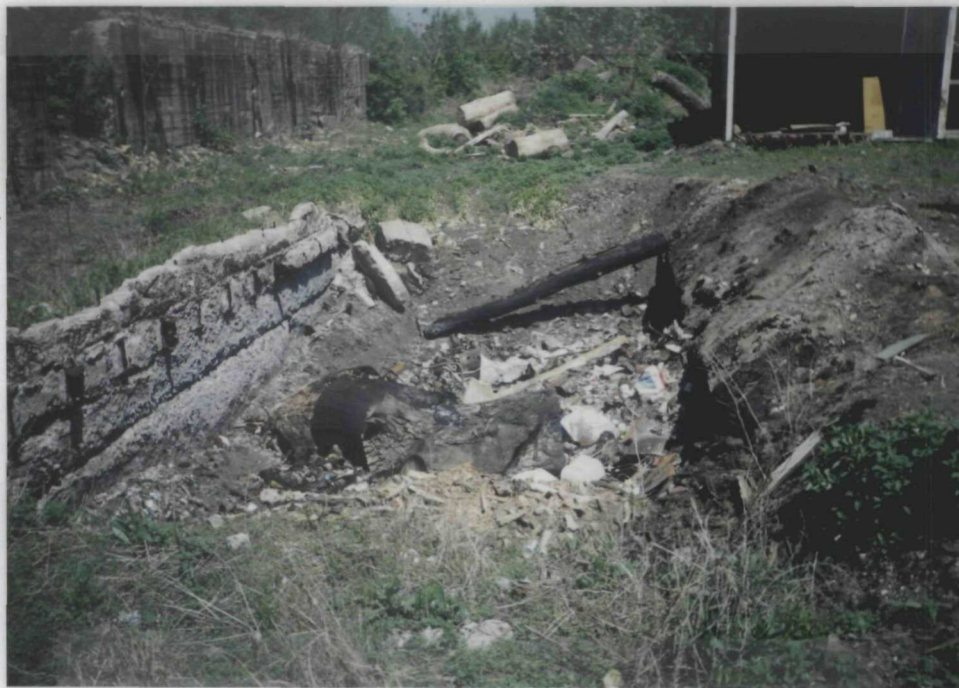
Description: Reconnaissance photo taken facing north, showing a solid waste burning pit found onsite, near battery 4.

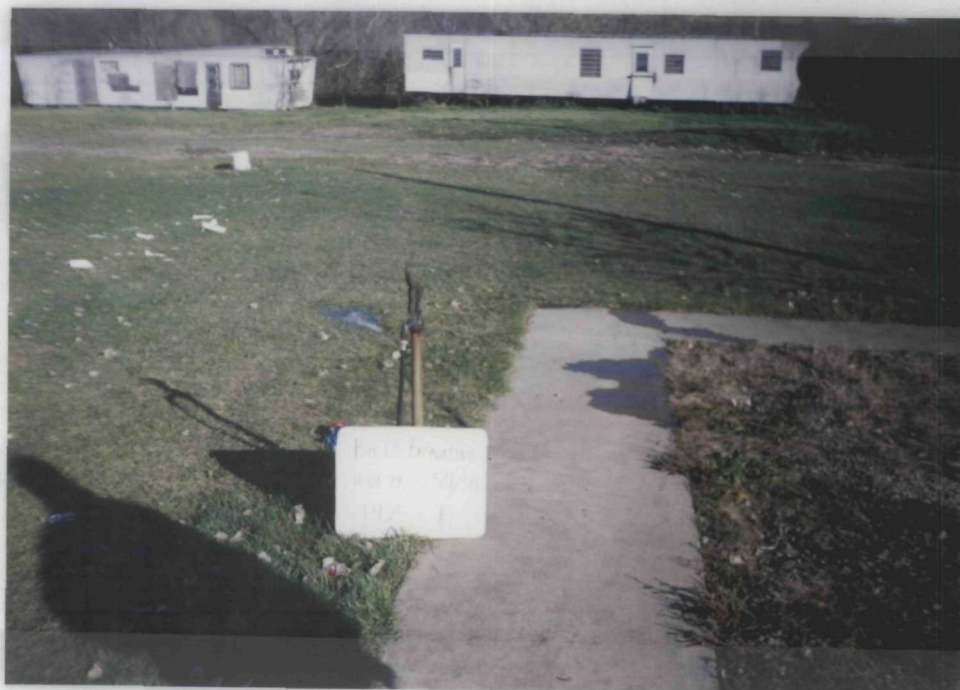
Description: Photo taken facing east, showing the onsite well where groundwater sample RW01 was collected.

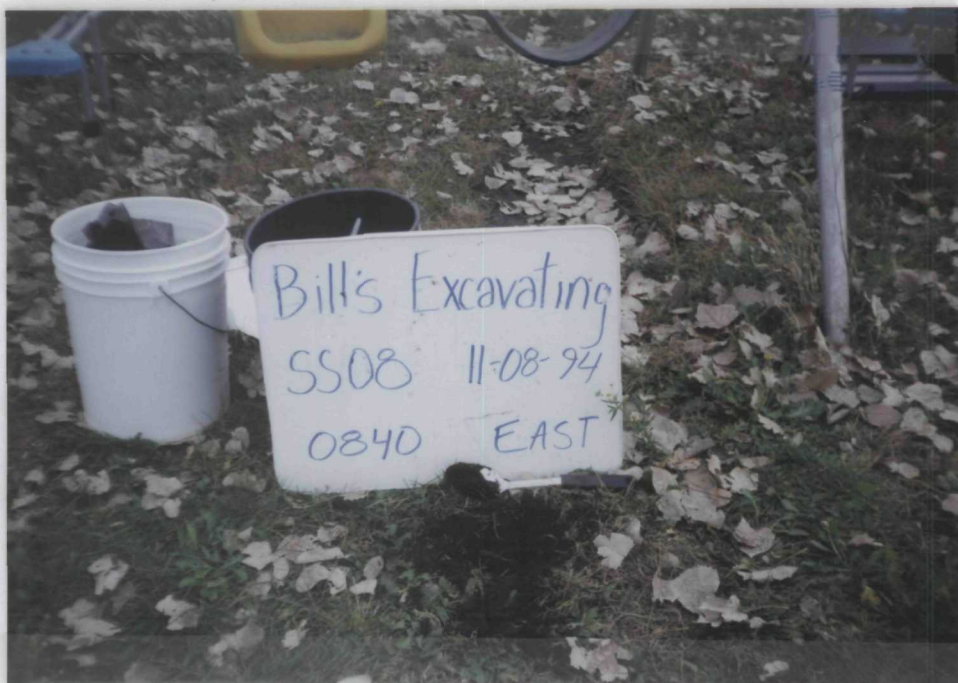
Description: Photo taken facing east, close-up showing the SS08 soil sampling location.

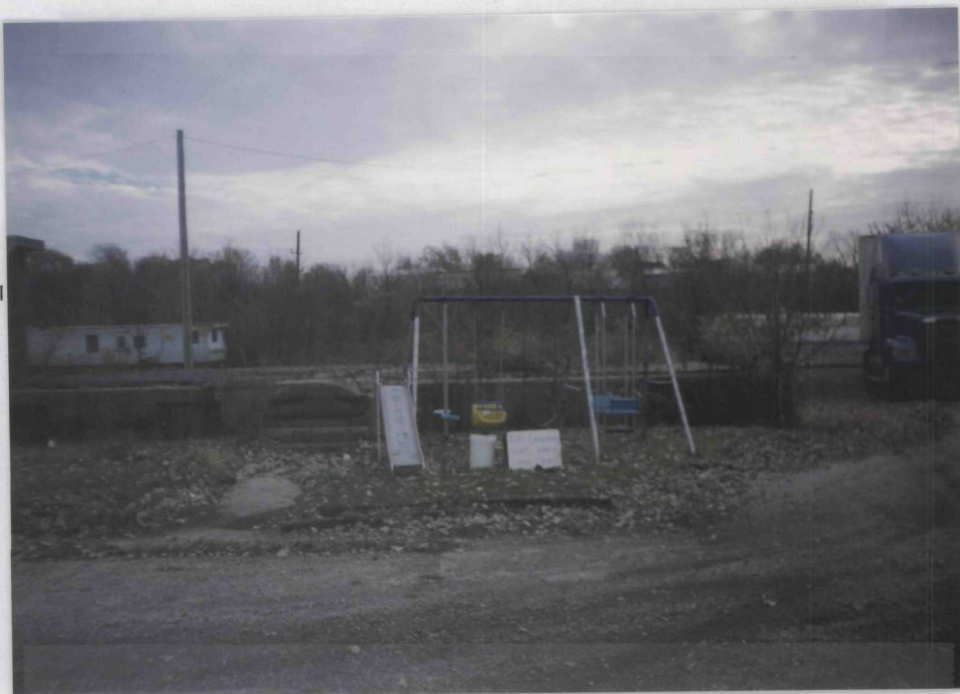
Site: Bill's Excavating Site
Proj. #: 71280.121
Roll: 2 Photo #: 4
Date: 11-08-94 Time: 0841
Description: Photo taken facing east,
showing the area with a
children's swing set where soil
sample SS08 was collected.

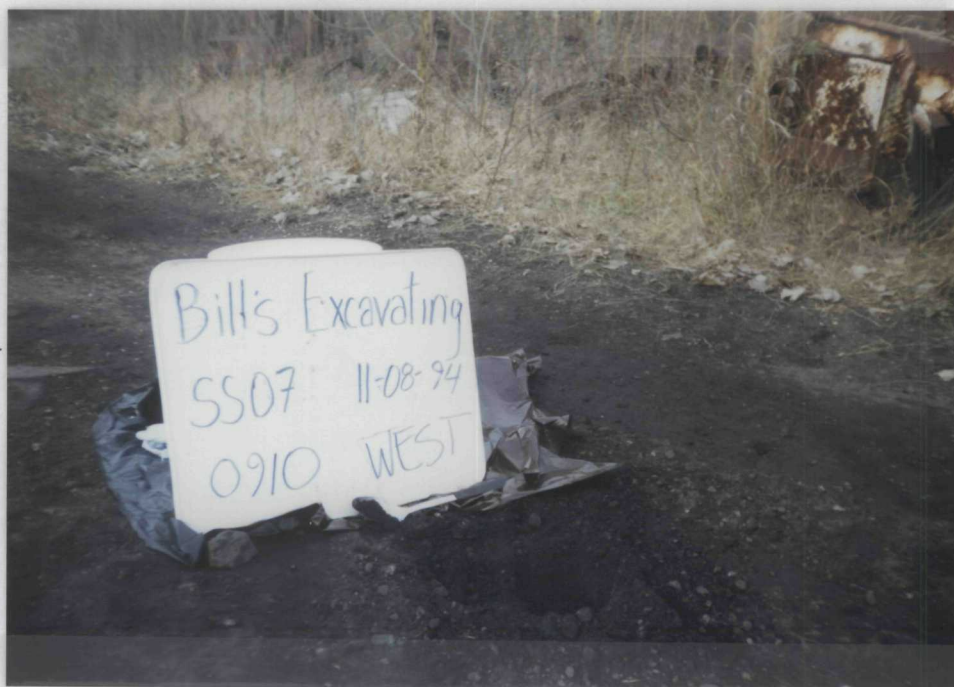
Site: Bill's Excavating Site
Proj. #: 71280.121
Roll: 2 Photo #: 5
Date: 11-08-94 Time: 0910
Description: Photo taken facing west, close-
up showing the SS07 sampling
point.

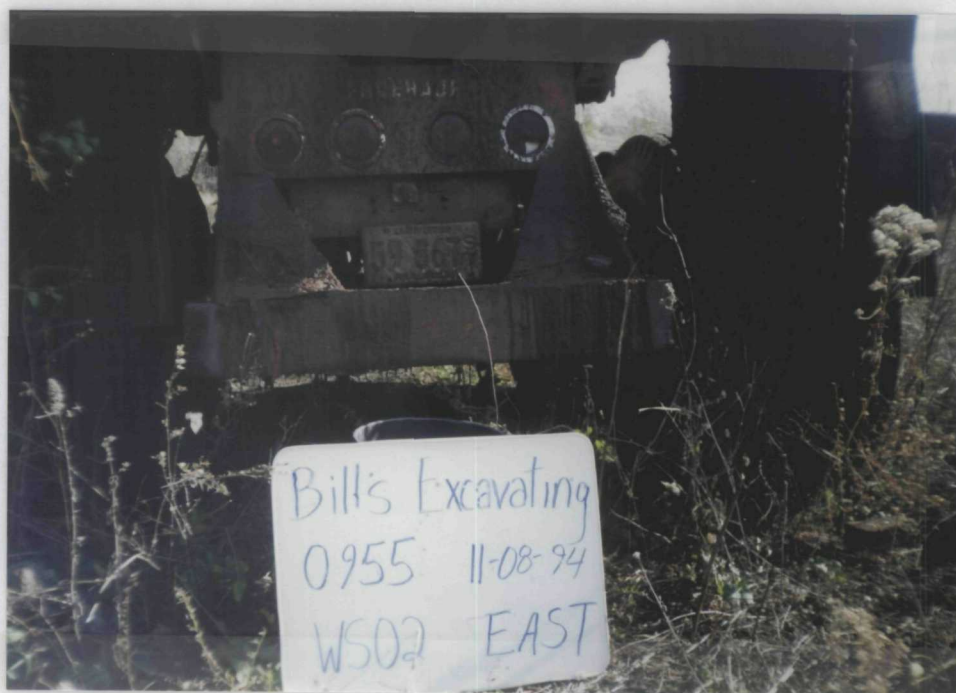
Site: Bill's Excavating Site
Proj. #: 71280.121
Roll: 2 Photo #: 7
Date: 11-08-94 Time: 0955
Description: Photo was taken facing east,
showing the trailer where waste
source sample WS02 was
collected.

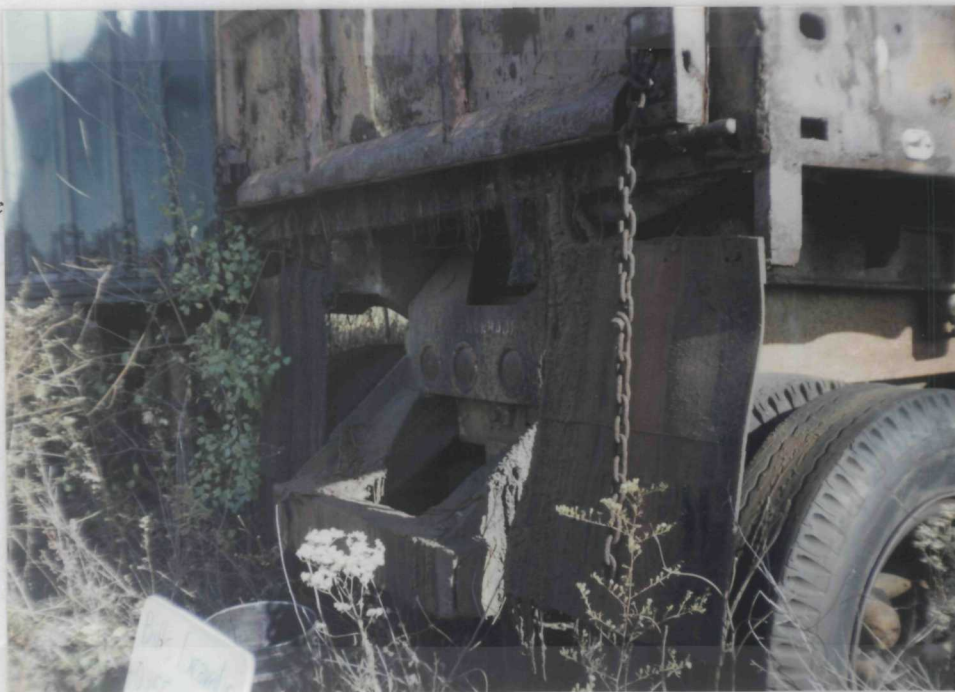
Site: Bill's Excavating Site
Proj. #: 71280.121
Roll: 2 Photo #: 8
Date: 11-08-94 Time: 0956
Description: Photo was taken facing
northeast, showing the back
end of the trailer where waste
source sample WS02 was
collected.

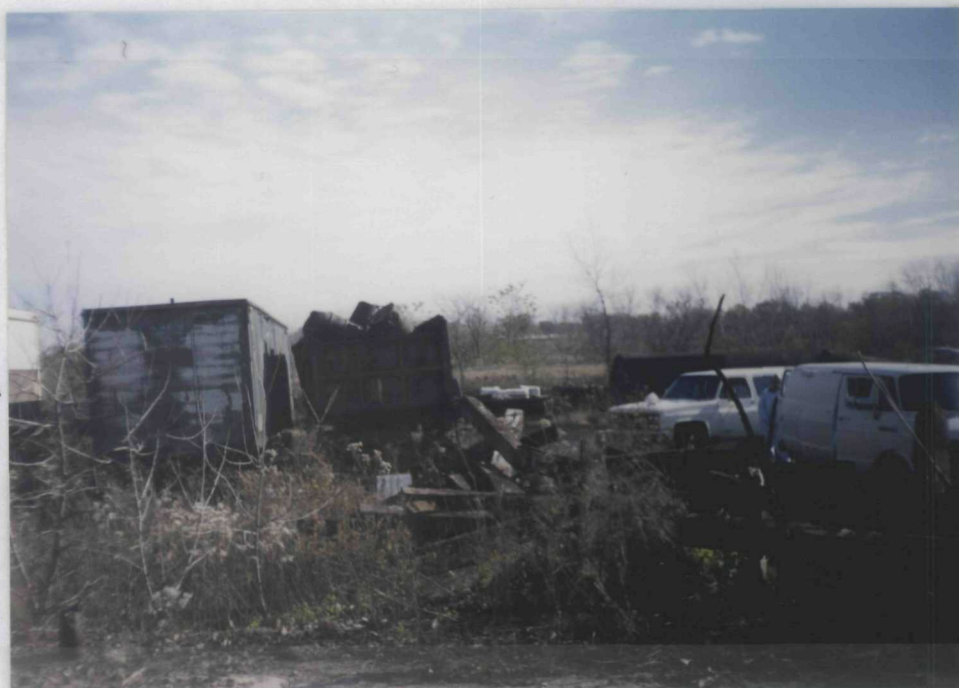
Site: Bill's Excavating Site
Proj. #: 71280
Roll: 2 Photo #: 9
Date: 11-08-94 Time: 0957
Description: Photo was taken facing
northeast, showing the area
where the trailer with drums is
located and sample WS02 was
collected.

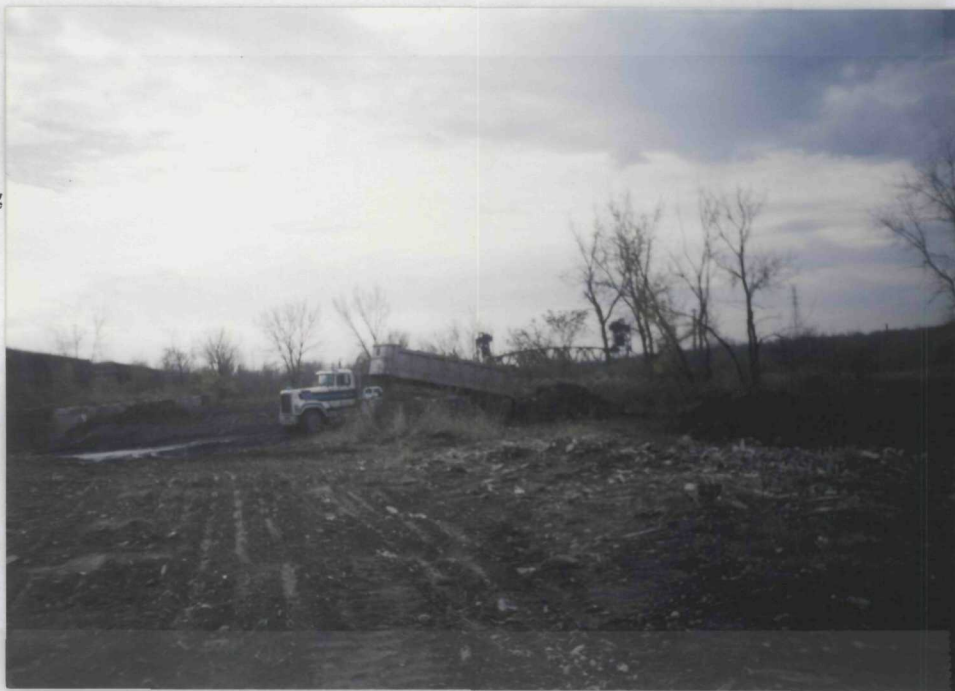
Description: Photo taken facing northwest, showing a dump truck dumping fill material to cover the coal tar-contaminated area in the northwest section of the site.

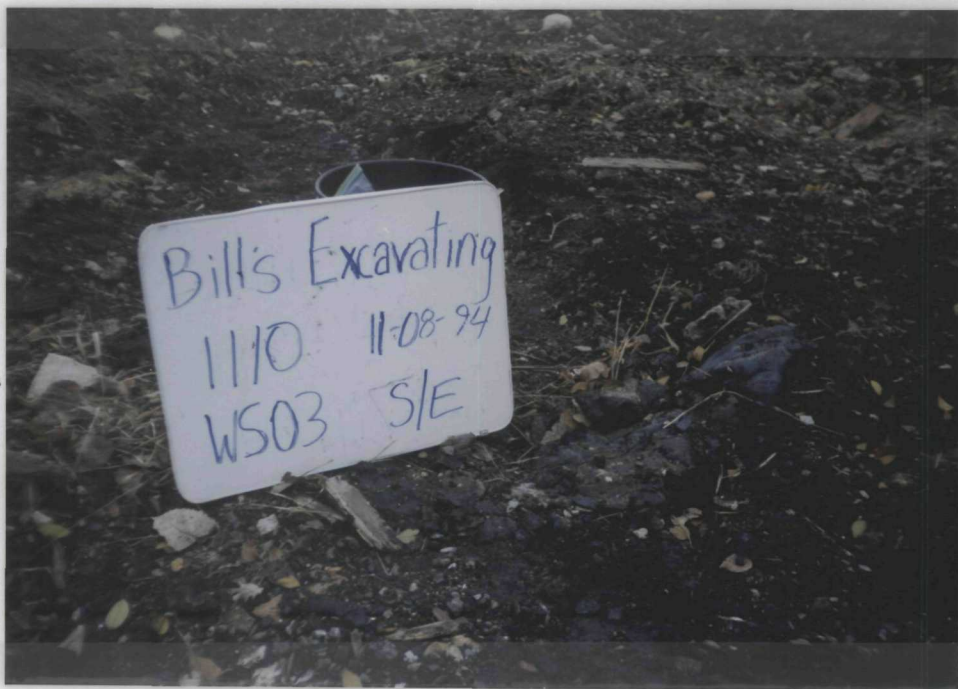
Description: Photo taken facing southeast, close-up showing spot where waste source sample WS03 was collected.

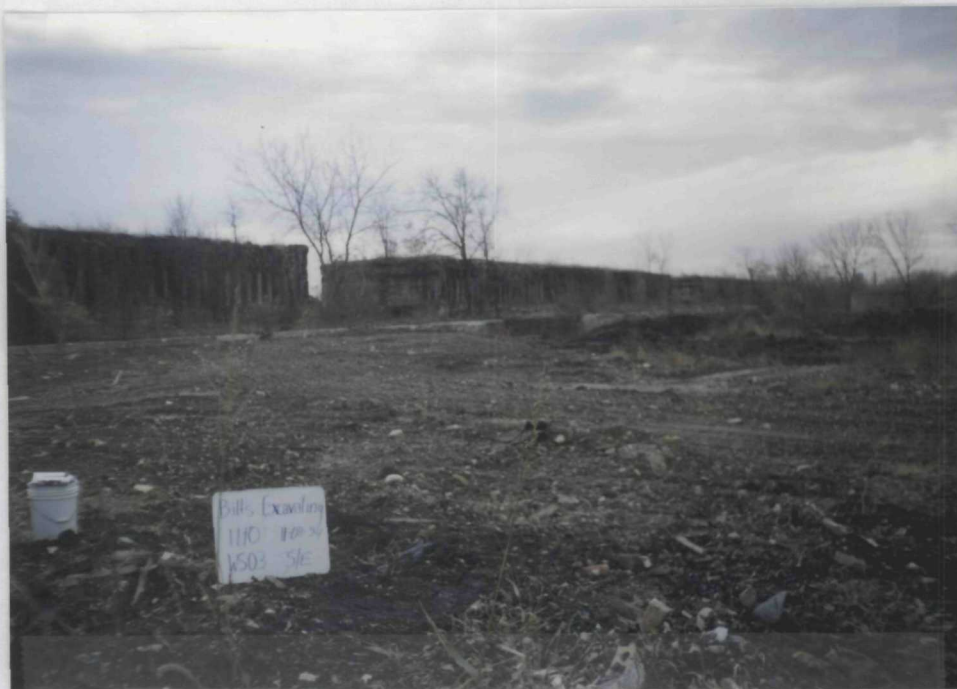
Site: Bill's Excavating Site
Proj. #: 71280.121
Roll: 2 Photo #: 12
Date: 11-08-94 Time: 1111
Description: Photo taken facing southeast,
showing the area where waste
source sample WS03 was
collected.

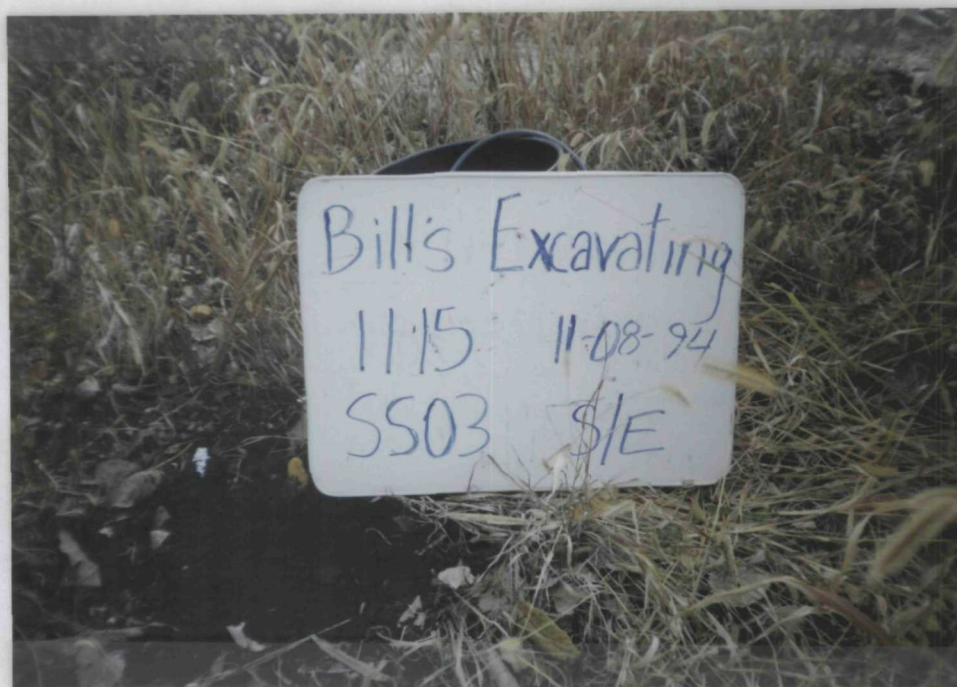
Site: Bill's Excavating Site
Proj. #: 71280.121
Roll: 2 Photo #: 13
Date: 11-08-94 Time: 1115
Description: Photo taken facing southeast,
close-up of the SS03 soil
sample location.

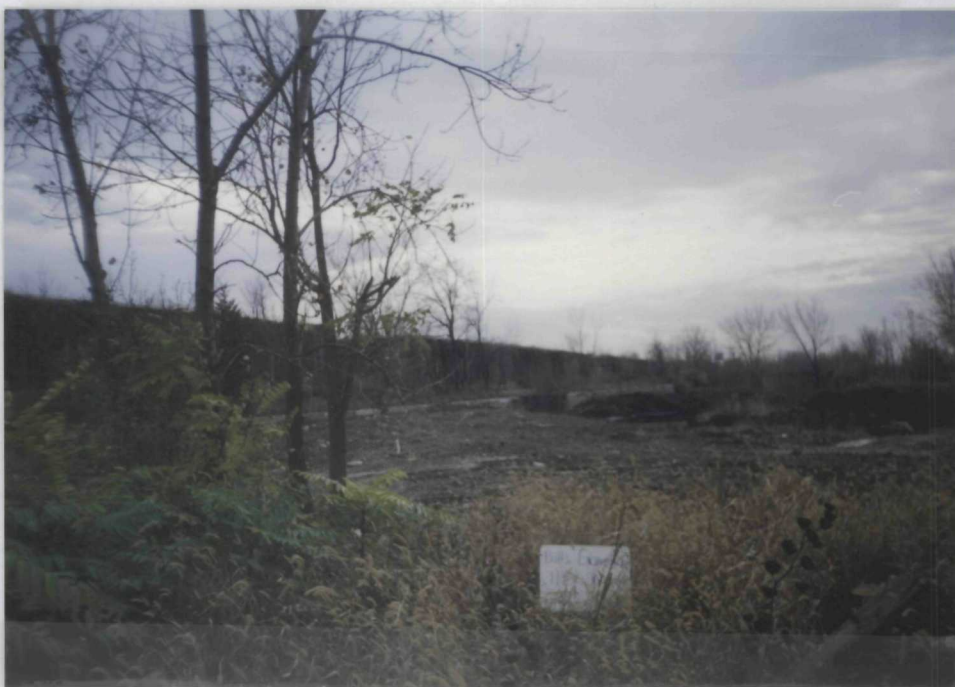
Site: Bill's Excavating Site
Proj. #: 71280.121
Roll: 2 Photo #: 14
Date: 11-08-94 Time: 1116
Description: Photo taken facing southeast,
showing the area where soil
sample SS03 was collected.

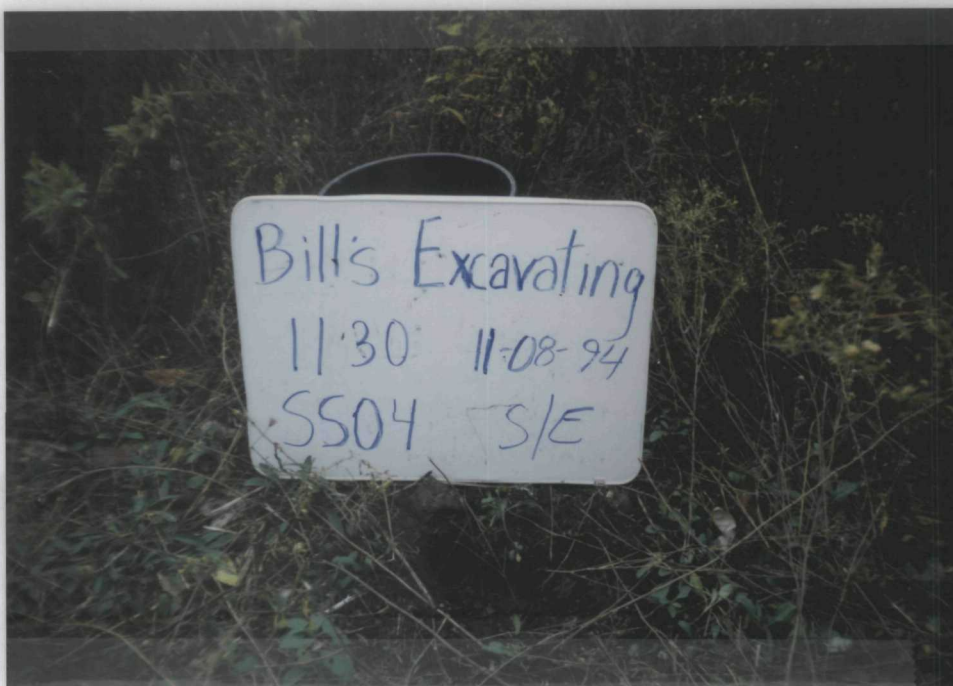
Site: Bill's Excavating Site
Proj. #: 71280.121
Roll: 2 Photo #: 15
Date: 11-08-94 Time: 1130
Description: Photo taken facing southeast,
showing a close-up of the soil
sample SS04 sampling spot.

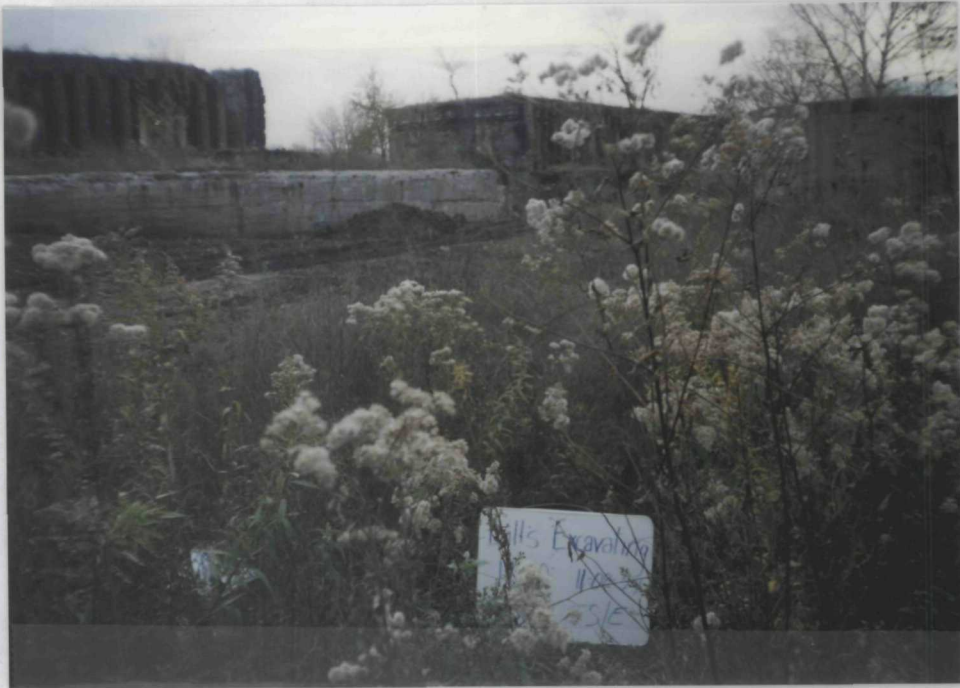
Site: Bill's Excavating Site
Proj. #: 71280.121
Roll: 2 Photo #: 16
Date: 11-08-94 Time: 1131
Description: Photo taken facing southeast,
showing the area where SS04
was collected.

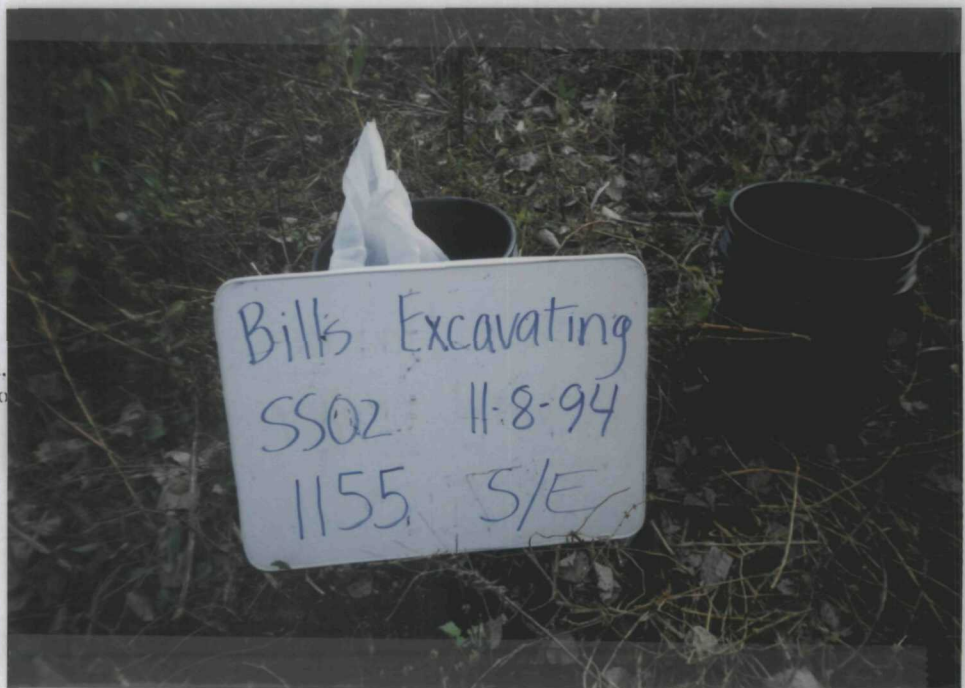
Site: Bill's Excavating Site
Proj. #: 71280.121
Roll: 2 Photo #: 17
Date: 11-08-94 Time: 1155
Description: Photo taken facing southeast,
showing a close-up of the spot
where soil sample SS02 was
collected.

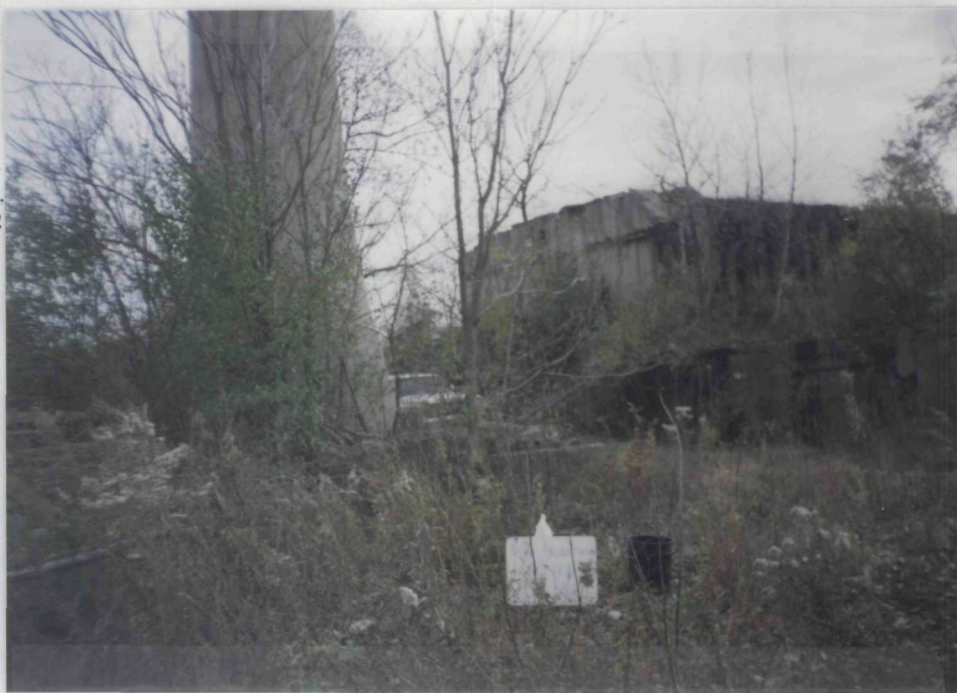
Site: Bill's Excavating Site
Proj. #: 71280.121
Roll: 2 Photo #: 18
Date: 11-08-94 Time: 1156
Description: Photo taken facing southeast,
showing the area where SS02
was collected.

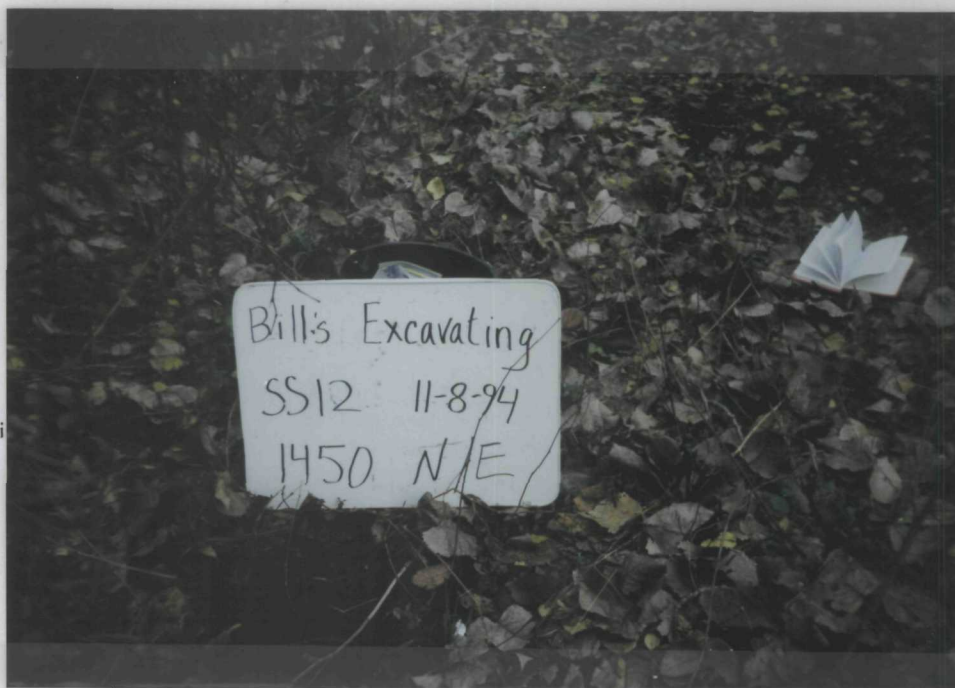
Site: Bill's Excavating Site
Proj. #: 71280.121
Roll: 2 Photo #: 19
Date: 11-08-94 Time: 1450
Description: Photo taken facing northeast,
close-up of the spot where soil
sample SS12 was collected.

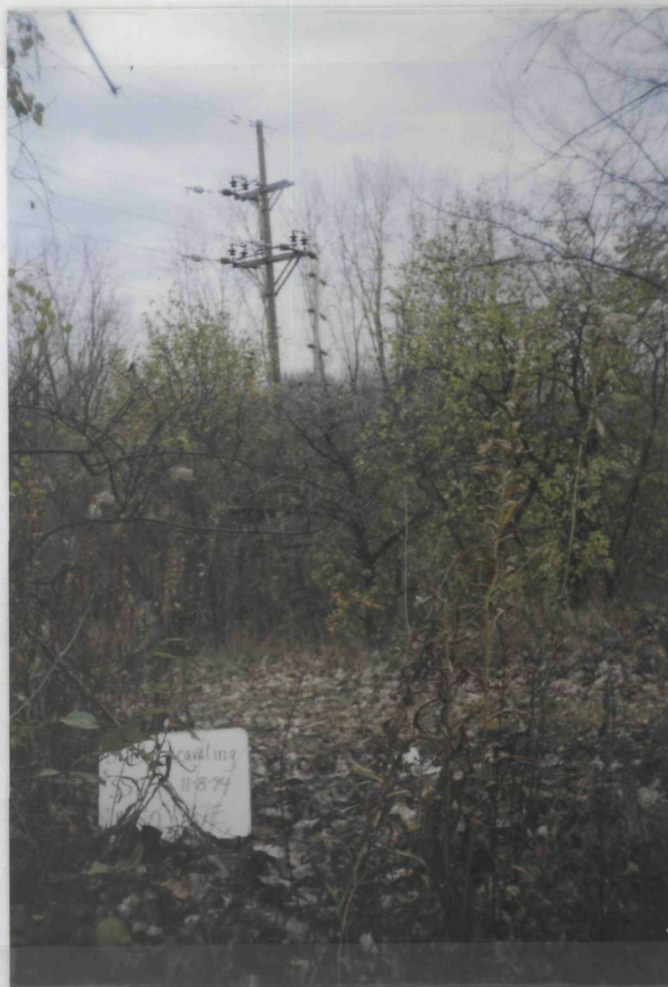
Site: Bill's Excavating Site
Proj. #: 71280.121
Roll: 2 Photo #: 20
Date: 11-08-94 Time: 1451
Description: Photo taken facing northeast,
showing the wooded area
where soil sample SS12 was
collected.

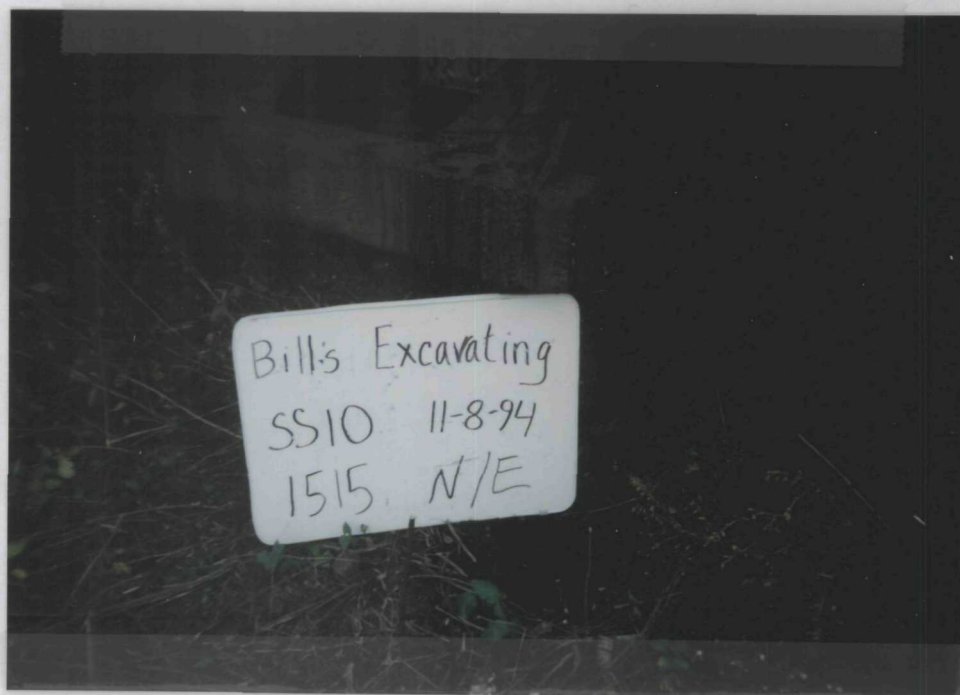
Site: Bill's Excavating Site
Proj. #: 71280.121
Roll: 2 Photo #: 21
Date: 11-08-94 Time: 1515
Description: Photo taken facing northeast,
showing the spot behind the
open trailer where soil sample
SS10 was collected.
